## Ústí nad Labem

### R49.1 – Safety Audit in Ústí nad Labem

20 December 2010

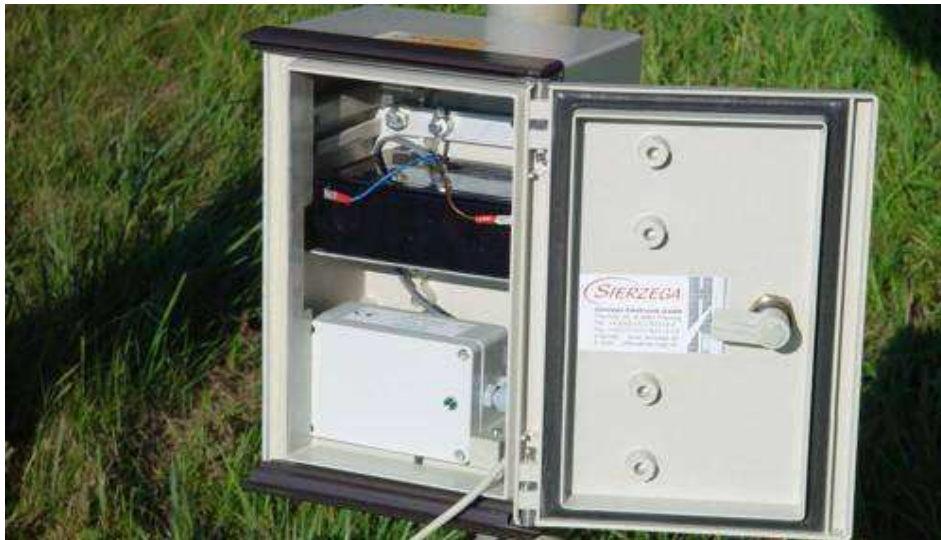
Outcomes of the measurements are information on the composition of traffic flow based on measuring vehicle lengths (1<sup>st</sup> category – motorcycles, 2<sup>nd</sup> category – cars, 3<sup>rd</sup> category – freight vehicles, 4<sup>th</sup> category – buses and trucks with a trail), their speed in km/h, the exact time of measurement, the date and directionality of each vehicle.

Figure 2 - Measuring equipment SierzeGA SR

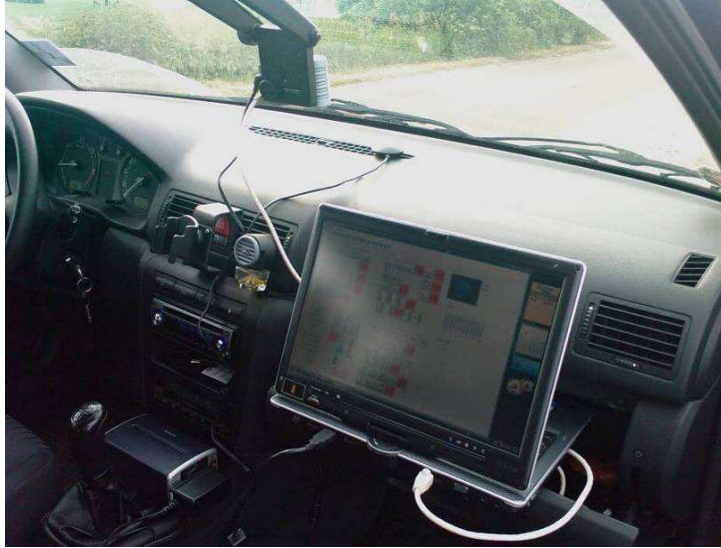
- PC – Laptop, tablet category running with MS XP, MS Vista or Microsoft Windows 7
- Full HD camera with a holder attachable into the vehicle
- GPS (or DGPS) with the protocol NMEA connected via a serial port or USB port
- A car power inverter for powering the CL adapter

Figure 6 - Hardware attached in the vehicle
