MIMOSA

Measure Evaluation Results

TAL 5.1 Improvement of Visibility and Safety of Crosswalks and Cycle Tracks

Date: February 2013

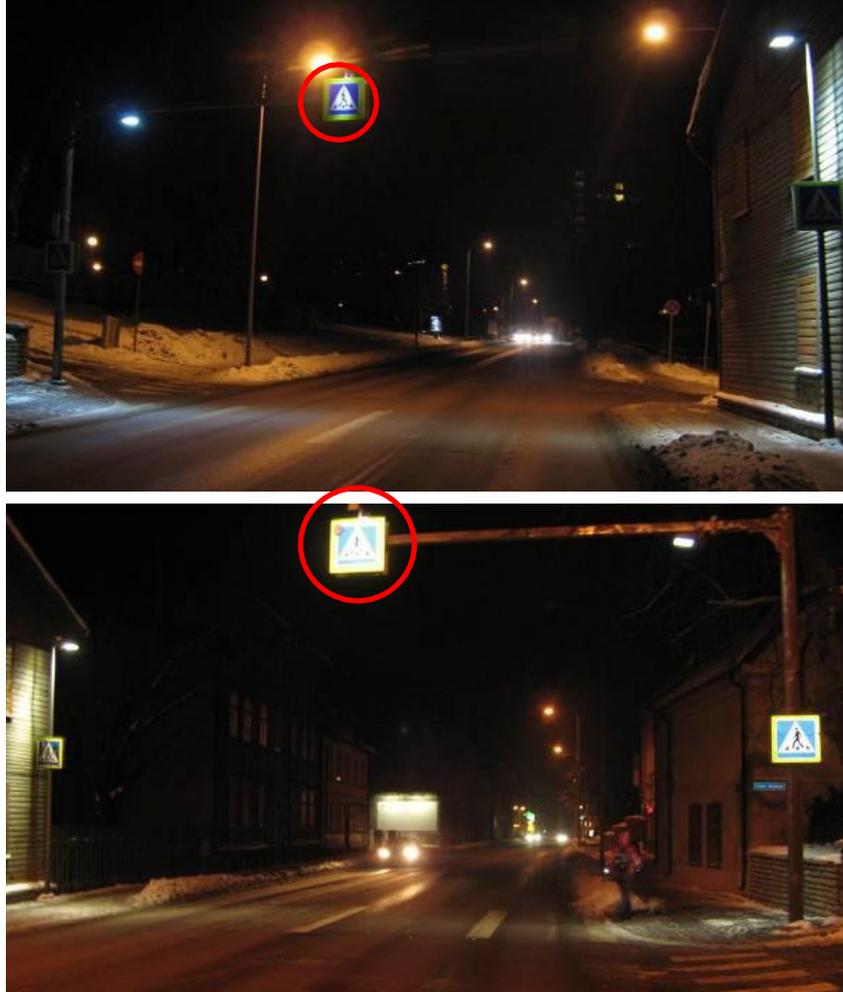
1. A **spot-lighted crosswalk** sign was added above the crosswalk (Figure 1), as the crosswalk signs at street sides were not drawing enough attention in dark. The system functions together with street lighting, i.e. low light or dark conditions.

Figure 1 Additional spot-lighted traffic sign above the crosswalk

However, as was brought out by other cities on presentation of solution 1, it would be useful to start improving the crosswalk with a low-tech approach and repaint the zebra-marking on the pavement (see picture in the description of the solution in the Chapter B2). This recommendation was also appropriate for the other solutions according to the pictures. The reason for this was that the beginning of the MIMOSA project happened to coincide with the worst time of the economic downturn and elementary road maintenance suffered as a result. Since then, the situation has improved.

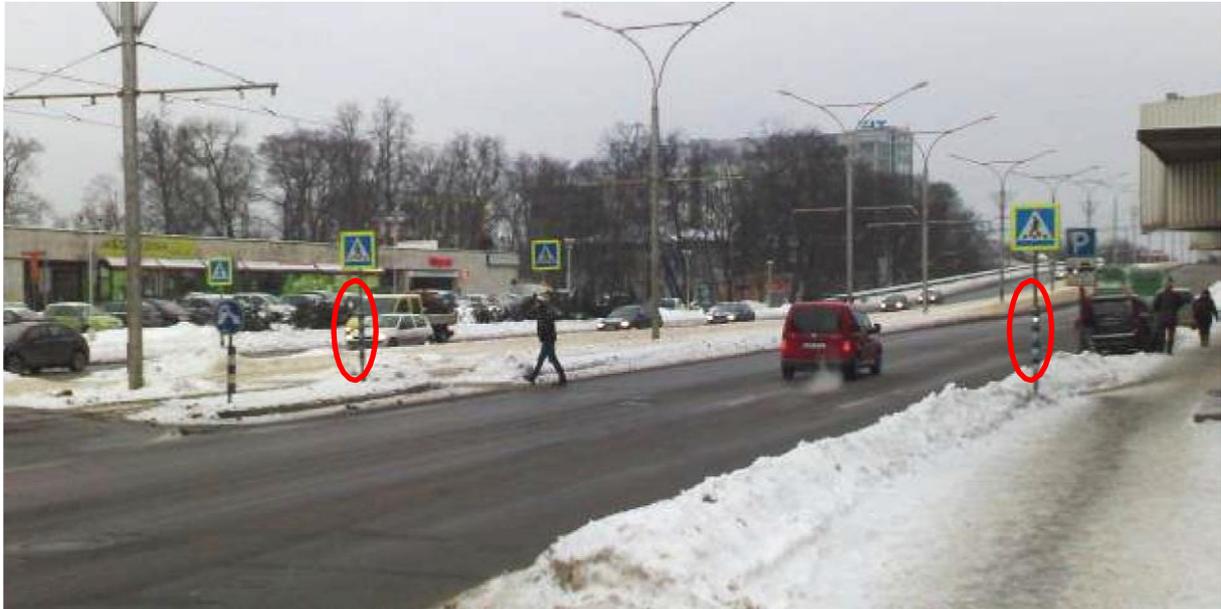
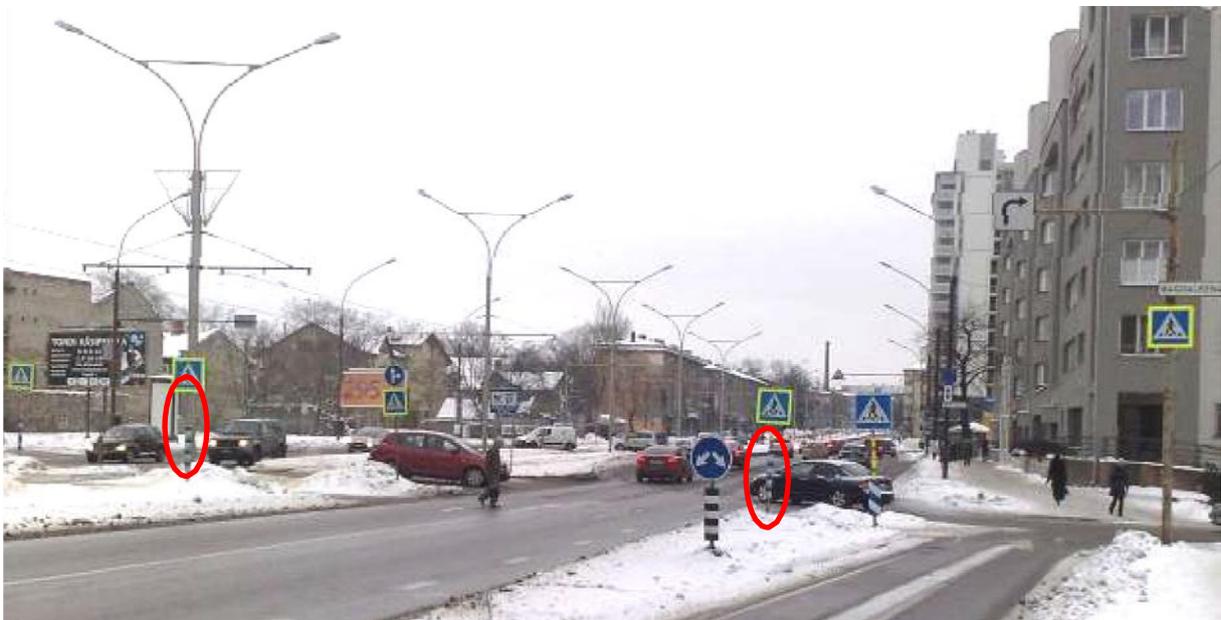
2. **LED-equipped blinking reflectors** were added to the crosswalk traffic sign poles. The blue LED-s start blinking (radar-activated) when pedestrians approach the crosswalk, thus drawing the attention of the approaching car drivers. The system functions 24 hours a day.

Figure 2 Pedestrian radar activated blue LED blinking reflectors on crosswalk traffic sign poles

The result was probably influenced by the malfunction of pedestrian radars, which sometimes caused the blue LED lamps to blink without any pedestrians around and sometimes the LED lamps did not blink even with an adult person crossing the road.

- The solution is technically complicated, requires electrical power and has a high cost compared to the effect it achieves;
- There are problems with the reliability of the radar, sometimes creating an adverse effect while blinking the LED-s with no pedestrians around or not blinking when pedestrians are using the crosswalk;
- The blinking LED-s are not always easily observed in the case of lighted and diverse backgrounds;
- If the solution is implemented on a wider scale the drivers will get used to paying a higher level of attention to the pedestrians at crosswalks with blinking LED's and accordingly will most probably pay lower attention to the pedestrians at the crosswalks without special solutions.

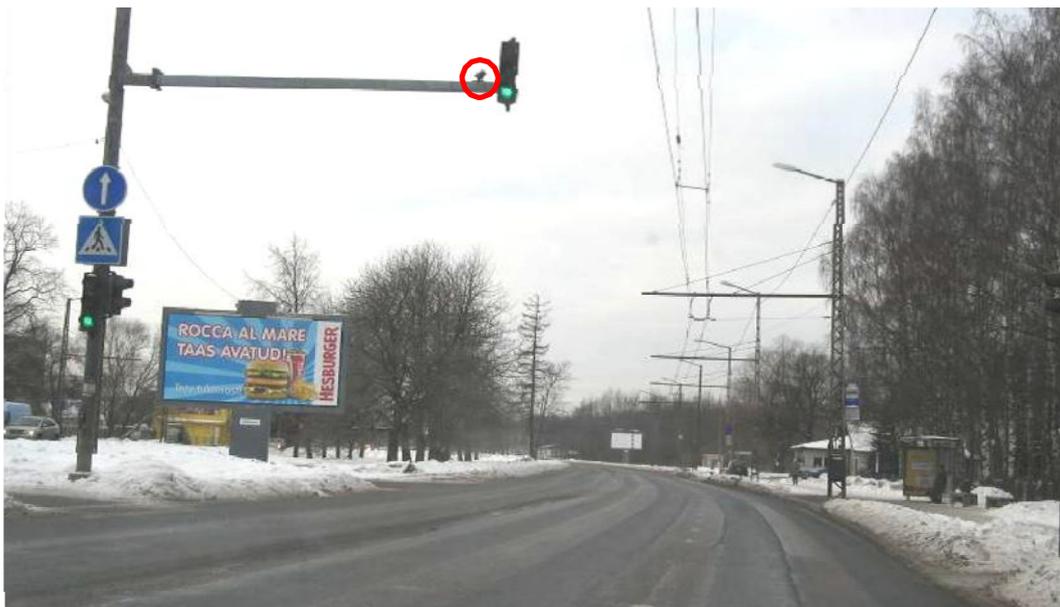
3. A speed sensor was added to the traffic lights of the pelican crosswalk (with a push button for pedestrians). The traffic light for car drivers is constantly red and switches to green only if approaching drivers are driving within the speed limit of 50 km/h permitted in the location. The system functions outside peak hours in traffic, i.e. 21:00-07:00 when traffic calming is needed most due to low traffic volumes.

Figure 4 Traffic lights with a speed radar (sensor to the left of the upper traffic light)

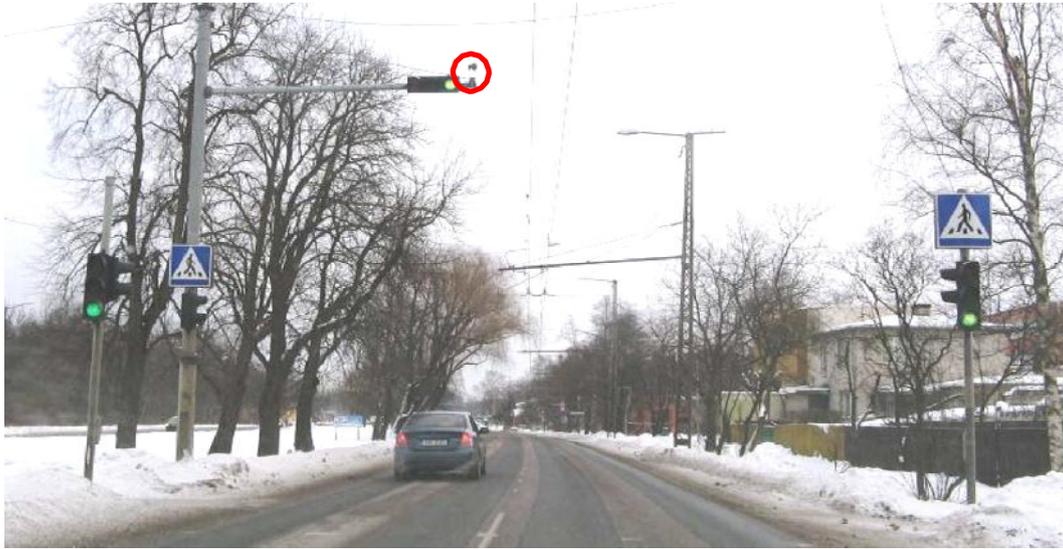
4. A **speed sensor was added to the traffic lights** of the pelican crosswalk (regulated crosswalk with a push button for pedestrians). The solution is otherwise same as the solution 3 except that the traffic light is constantly green instead of red and sensor switches it to red if an approaching car is exceeding the speed limit of 70 km/h permitted in the location. The system functions outside peak hours in traffic, i.e. 21:00-07:00 when traffic calming is needed most due to low traffic volumes.

Figure 5 Traffic lights with speed radar (sensor to the right of the upper traffic light)

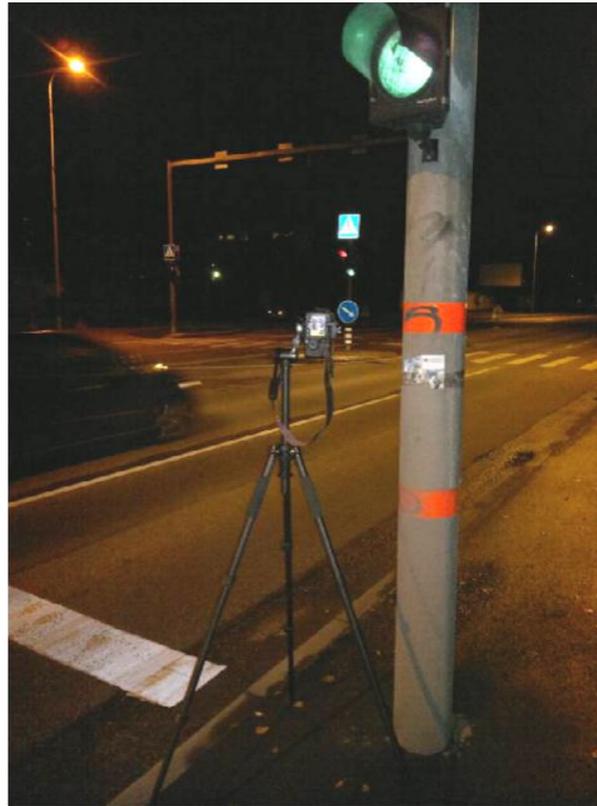
Instead, an experimental indicator was specially developed for the technical solution, measuring the difference in the amount of light emitted by the scenario with a traffic light in normal and dimmed mode. The measurements were made with a normal digital SLR camera taking pictures of the scene with traffic light (figure 7) and setting the exposure level to 0 manually on both normal and dimmed light pictures. The exposure level was set to 0 with an adjusting shutter speed while the yellow traffic light was on. The relative difference in illumination can be seen from the different shutter speeds which were needed for taking the pictures with exposure level 0. The luminosity of the scene is important while a driver approaches the crosswalk. With more light emitted from the traffic light, the human eye adjusts the pupil of the eye to the higher luminosity and reduces the ability to see the less illuminated parts of the scene. The effect is similar to the experience on a motorway at night when it is difficult to see the road ahead while meeting oncoming cars, especially when they have their high beams on. The difference can be important, if it is the difference between noticing and not noticing a pedestrian.

Figure 7 Field work with the indicator TAL

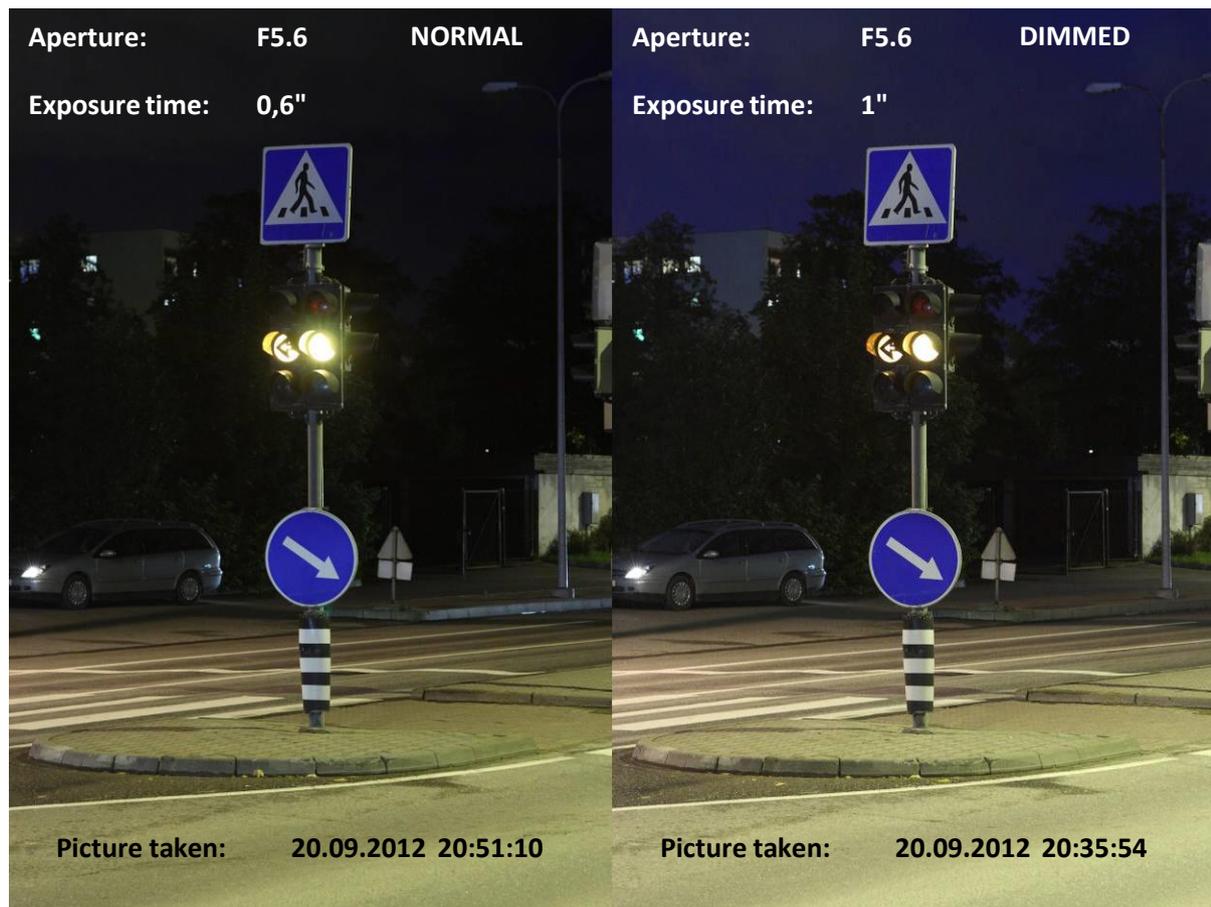
Solution 5. The effect of the traffic light dimmer was evaluated with an experimental indicator, measuring the luminosity of the scene (composition of objects on a picture) containing the traffic light. The comparison between the same scene with a normal traffic light and with a dimmed traffic light is presented in **Figure 13**.

While the difference between the normal and dimmed light was noticeable, the difference is too small to be noticed by drivers unaware of the dimmer. However, as can be seen from the pictures and exposure times on **Figure 13**, there is clear measurable difference.

Figure 13 Difference between normal and dimmed traffic light in the scene

The background sky is a good example of the effect. The background trees are still distinguishable from the dark blue sky on the right picture. The reason is because of the lower illumination of the dimmed traffic light the whole scene has to be brighter (longer exposure) so that the total exposure of the scene would be 0. The difference would be the same with a pedestrian – distinguishable from the background or not.

The result from the measurements is that the scene with normal traffic light had 40% higher luminosity than the same scene with a dimmed traffic light.
